INSTALLATION RESTORATION PROGRAM PHASE I: RECORDS SEARCH BEALE AFB, CALIFORNIA

UNITED STATES AIR FORCE STRATEGIC AIR COMMAND Deputy Chief of Staff Engineering and Services Offutt AFB, Nebraska 68113

April 1984

ENGINEERING-SCIENCE 57 Executive Park South, Suite 590 Atlanta, Georgia 30329

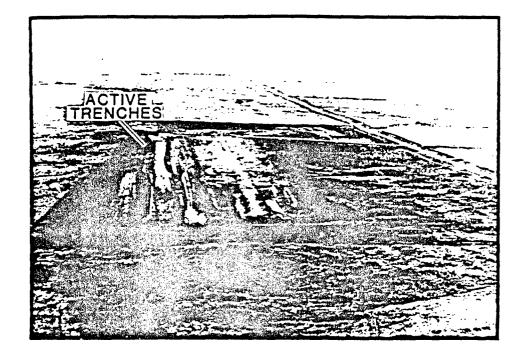
Landfill No. 3

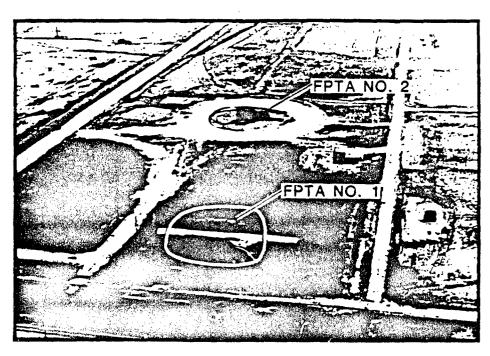
Fire Protection Training Areas No. 1 and 2

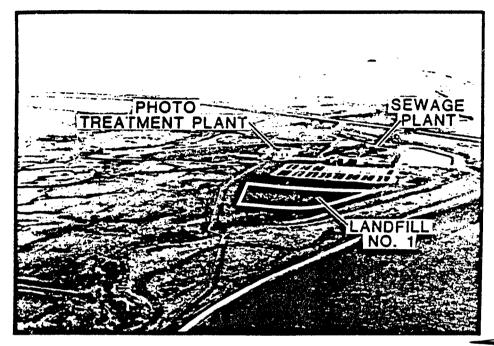
Landfill No. 1, Sewage Treatment Plant and Photo Wastewater Treatment Plant

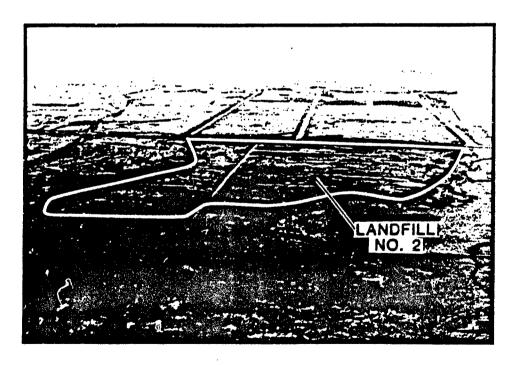
Landfill No. 2
